# Carters Beach, Queens County, Nova Scotia: An Assessment of Present Foredune Stability and Recommendations for Reducing Negative Human Impacts.

R.B. Taylor, Emeritus,

Geological Survey of Canada Atlantic,

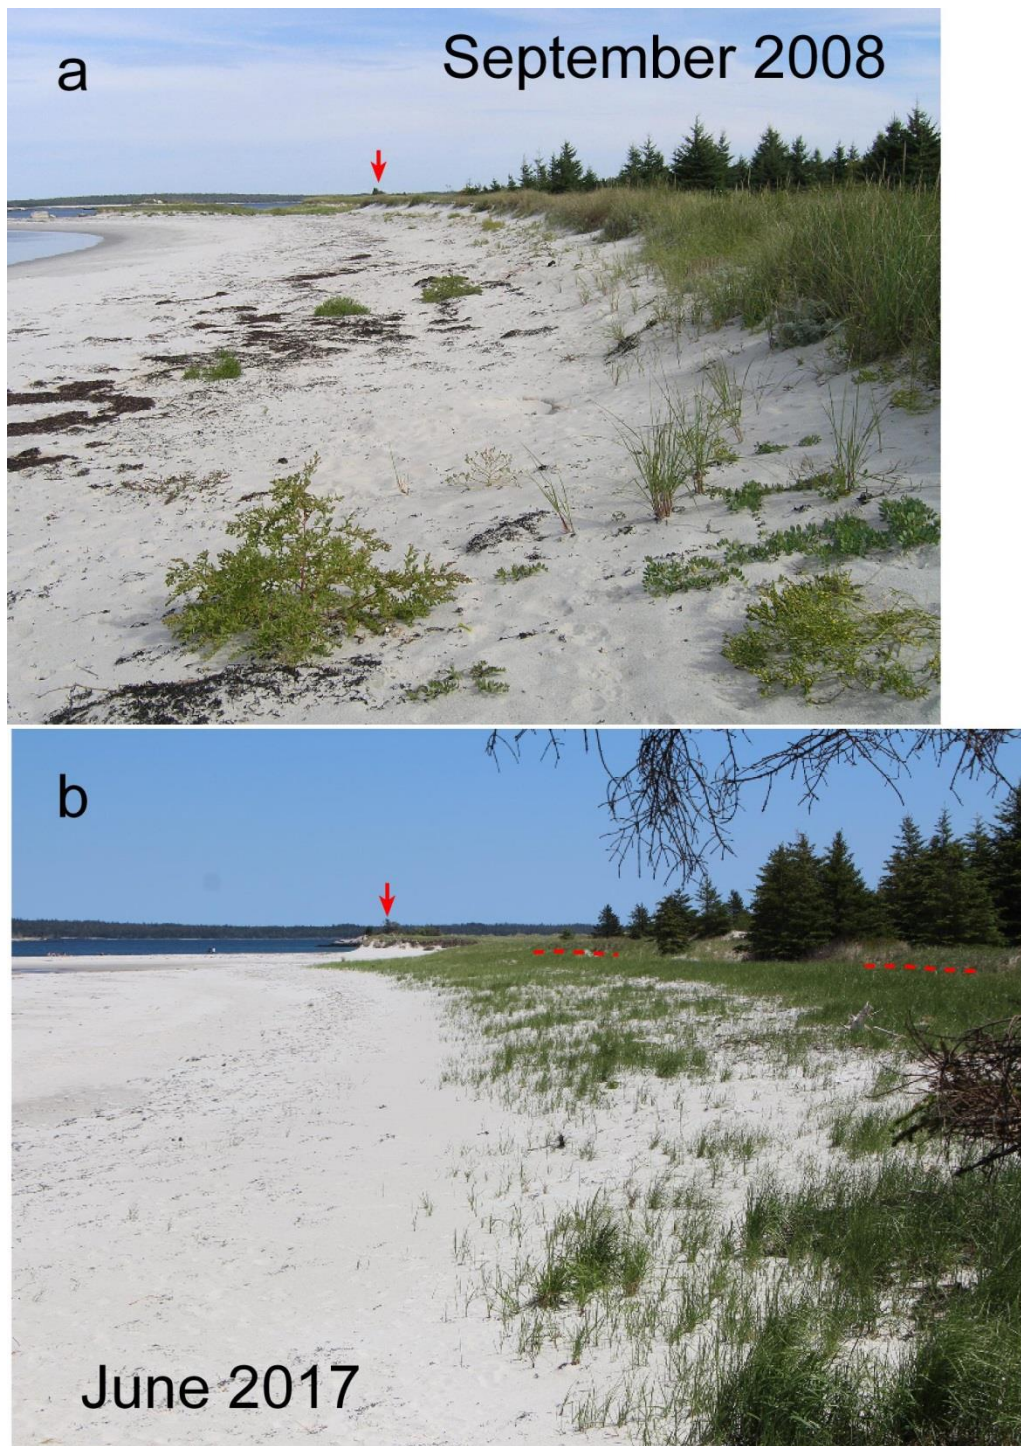
Figure 1. Between (a) 2008 and (b) 2017 the foredune along first beach (Carters Beach) has been eroded and naturally rebuilt a number of times. The dash line on the 2017 photo marks an older dune cut from waves generated by a Nor'easter a few years ago (Brian Fisher, local resident, pers. comm. 2017). The dune has built seaward as sand accumulated and became revegetated by June 2017.

- 3) enhance protection of foredune vegetation along both first and third beaches (Figs. 1,2) by posting signs along the seaward edge of the dune grass. The signs should remind people of the negative impact of sitting or trampling the dune grass and to avoid walking on the grass.

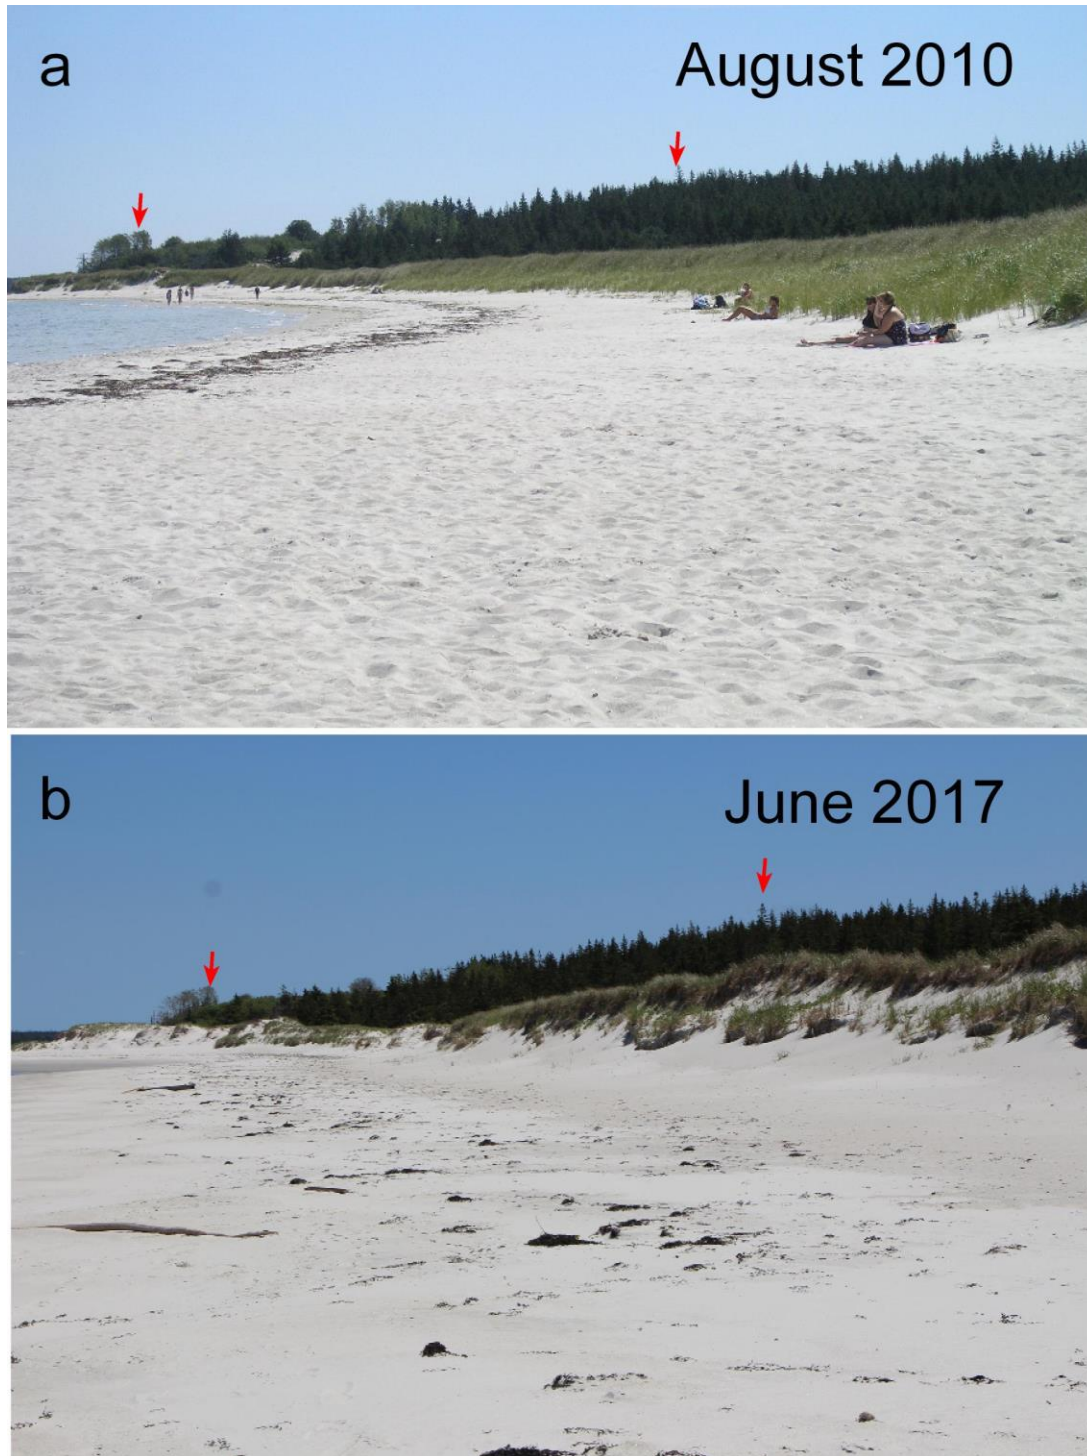
Figure 3. Second beach looking south in (a) 2010 and (b) 2017 illustrating less recovery of vegetation and foredune compared with changes observed along first and second beaches (Fig. 1 and 2), Carters Beach, Nova Scotia. The largest increase in dune blowouts was at the southern end of second beach. Arrows pointing to the same trees in both photos provide a visual reference for measuring foredune changes.

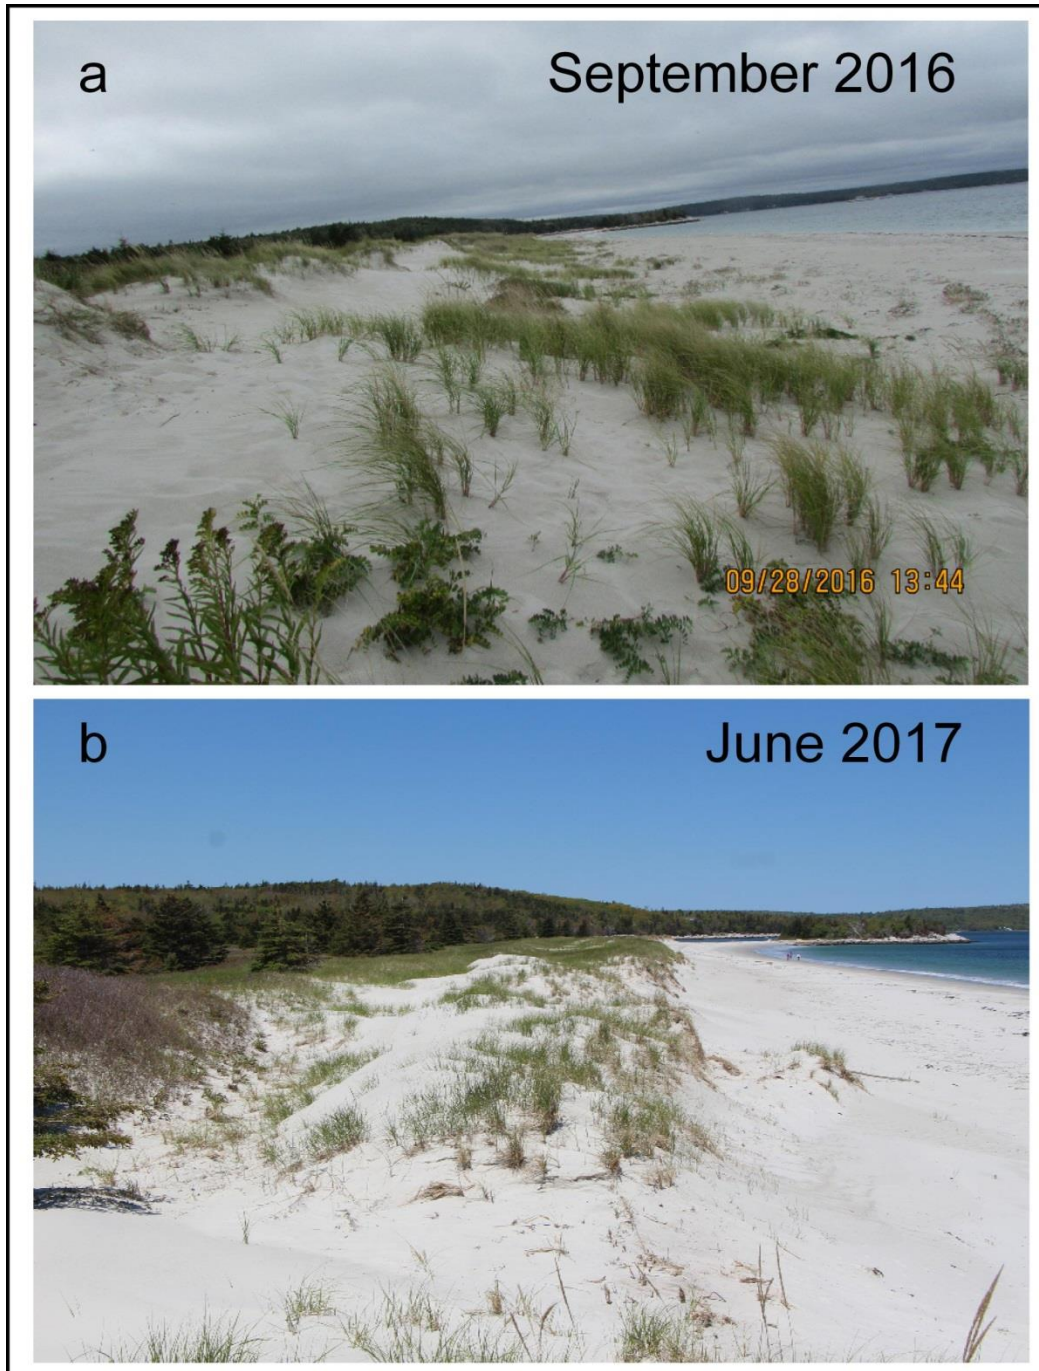
beach and dune morphology and relative position of large rocks with the beach suggest little overall change in beach width. Since September 2016 the seaward foredune slope has become steeper and been trimmed back, possibly by waves during the high water storm events in March and February of this year. Marram grass, present along the upper beach and base of the foredune in September 2016, is not visible in June 2017. Sand has accumulated along the base and top edge of the foredune. It is possible the marram grass has been buried and not had sufficient time to grow through the sand. Alternatively, the grass may have been removed by waves during the storms. Time will tell. Small cuts along the top of the foredune have allowed sand to migrate as parabolic dune features over the top edge of the foredune. This is a natural evolution of coastal dunes when they are forced to migrate landward due to rising sea level and a reduction in sediment supply. However in the past few years there has been a **significant** loss of foredune vegetation, increase in blowouts and areas of bare sand and increased abundance of sand mounds migrating across the older dunes along the south end of second beach. There is no specific explanation for the large deterioration in foredune condition based on the width of the present beach and sand abundance. Recent storms have impacted the beach and dunes but repetitive photos taken since 2008 suggest, in my opinion, that increased human activity observed by the local stewardship group may have triggered the larger changes or aggravated the situation.

Figure 4. Between September 2016 (a) and June 2017 (b) the slope of the foredune along second beach has increased, the grass cover along its base has decreased and sand migration across the top of the foredune has increased. The changes are natural and could be attributed to the high water storm events in February and March 2017 (2016 photo by Brian Fisher, Port Mouton).

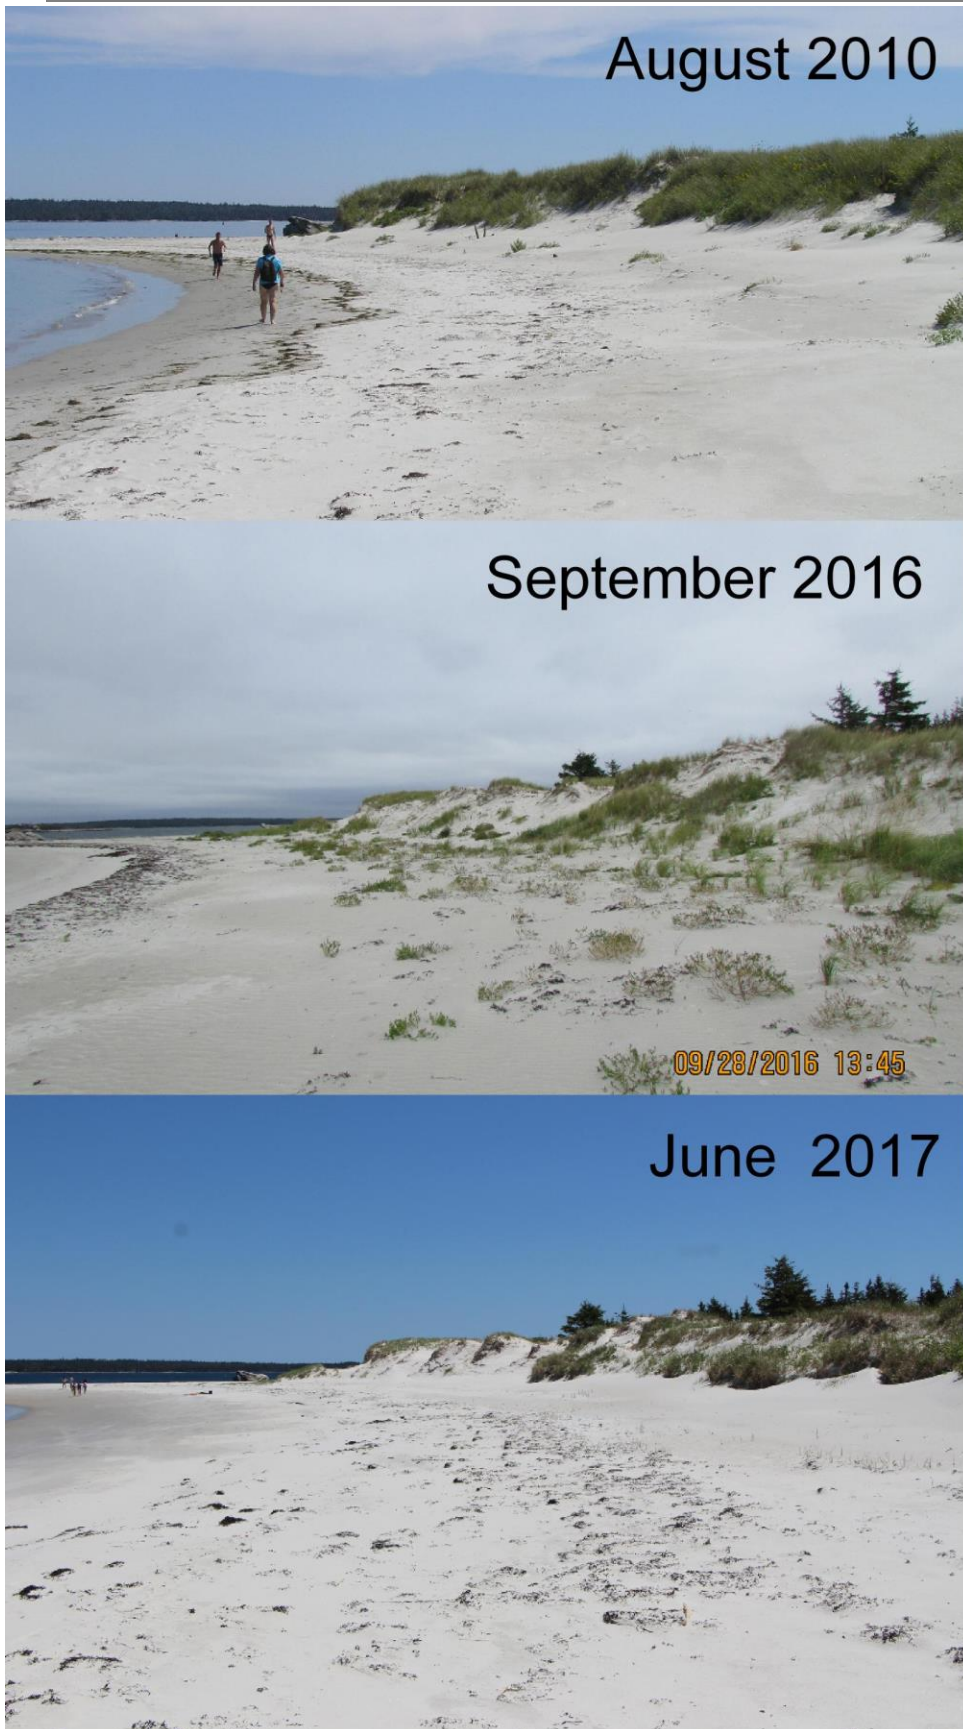
Figure 5. Sequence of photos illustrating the loss of vegetation and physical deterioration of the foredune along the southern end of second beach from (a) August 2010, to (b) September 2016 (photo by Brian Fisher, Port Mouton); and, to (c) June 2017. The severity of change along second beach compared with other parts of Carters Beach suggest the change may have been triggered or aggravated by human activity.

- 2) the base of the foredune at and near the south end of second beach could be roped or ribboned off , or as a minimum, signs should be posted asking for the publics support in protecting the park by not sitting, walking or climbing on the dunes. If by the end of the summer when the ropes, ribbon or signs are removed before the stormy season, a follow-up assessment is required (see monitoring below). The dune condition and natural spread of vegetation should be documented to assess the effectiveness of these management actions and whether other actions such as vegetation transplanting will be necessary the following spring.

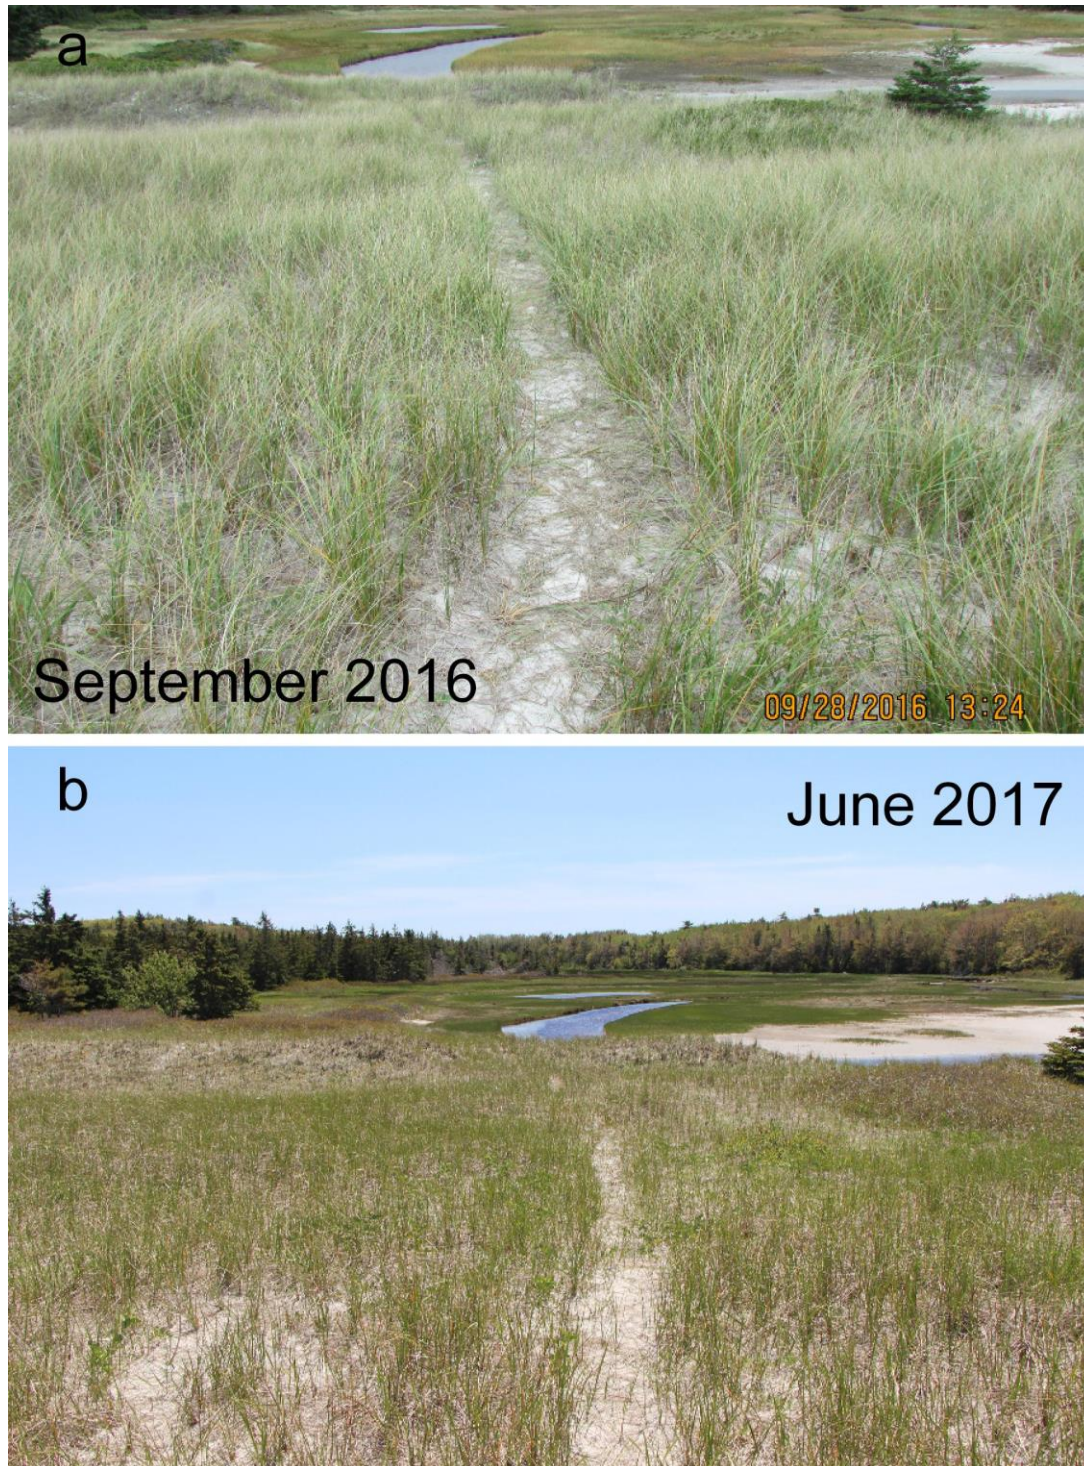
Figure 6. Views of the path that extends seaward from the highway along central Carters Beach and crosses the foredune adjacent to the stream that divides first and second beaches. (a) By September 2016 pedestrians had worn down the trail and trampled the vegetation but in (b) June 2017 grass was naturally spreading across the trail. Signs re-routing visitors away from this path to follow the edge of the stream would encourage more rapid recovery of vegetation across the path and stability of the dunes.

- 4) people walking along the central wooded trail from the road to the beach should be directed near the present beach to follow the river course rather than walking over the present foredune (Fig. 6) to reach the beach. This would protect the dune vegetation but might have implications for other biological concerns, e.g. birds, along the stream. It would also be useful to close off some of the many walking trails across the high dune adjacent the public access to third beach. It is difficult to prohibit people from walking across the high dune for a better view of Port Mouton Bay; however, by limiting the number of trails to one, it allows natural recovery of vegetation along other trails.
