Diver Observations in Port Mouton Bay,
August, 2007
- a comparison of seabed conditions at
existing and proposed aquaculture sites

Friends of Port Mouton Bay
Contribution #13, August 29, 2007

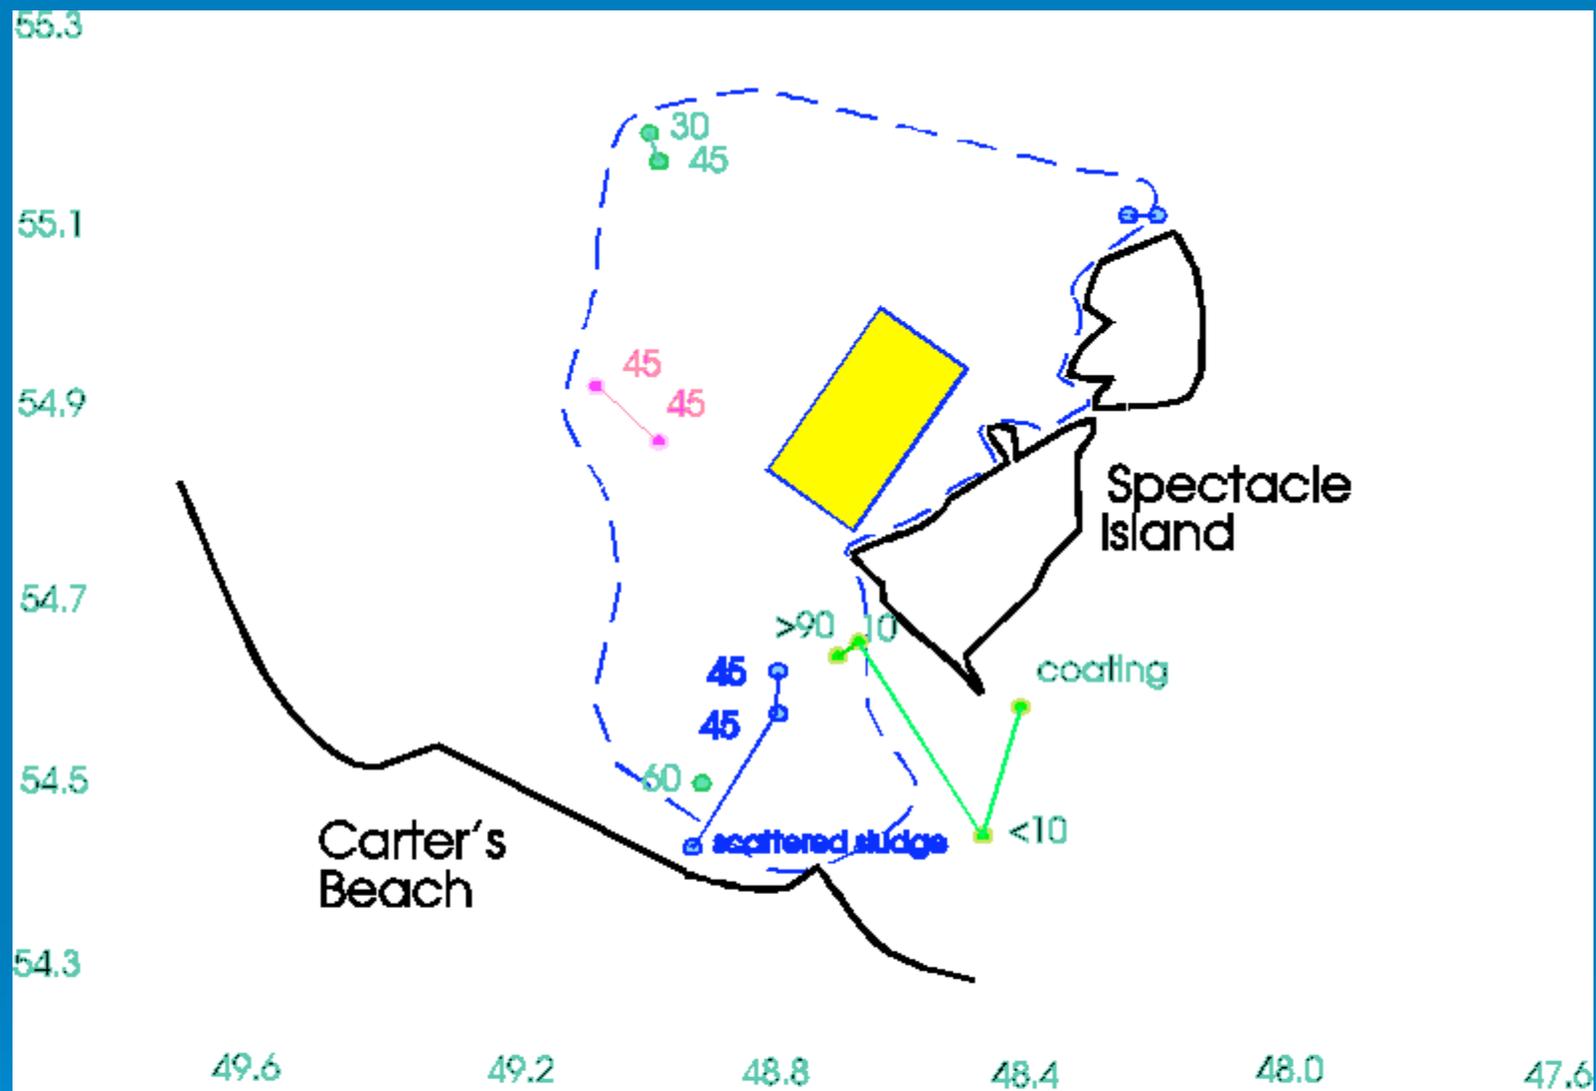
Chart of approximate footprint of waste on seabed showing depth (cm)
 Aug 1, Aug 3, Aug 10, Aug 15, 2007. Horizontal axis is minutes of longitude

west of 64 degrees W. Vertical axis is minutes of latitude north of 43 degrees N.
 Divers' swim tracks are indicated by solid lines. Updated to August 17, 2007.

- In August, 2007, divers discovered accumulated fluidized waste on the seabed from 30-90 cm thick, outside the boundaries of the Spectacle Island salmon aquaculture site. The divers report that this waste on the seabed supports little or no marine animal life, and that gas bubbles rise from the thickest layers. Holes from gas venting are common. A body of waste 60 cm in thickness lies within 100 m of Carter's Beach.

- Connecting the perimeter points identified by the divers suggests that the contaminated area can be an estimated 80 hectares of the seabed. This area of the waste footprint on the seabed is approximately 10 times greater than the area of the aquaculture site. In order to refine this estimate, diver surveys will continue. Contiguous areas beyond this footprint show marine life coated with a thin layer of waste.

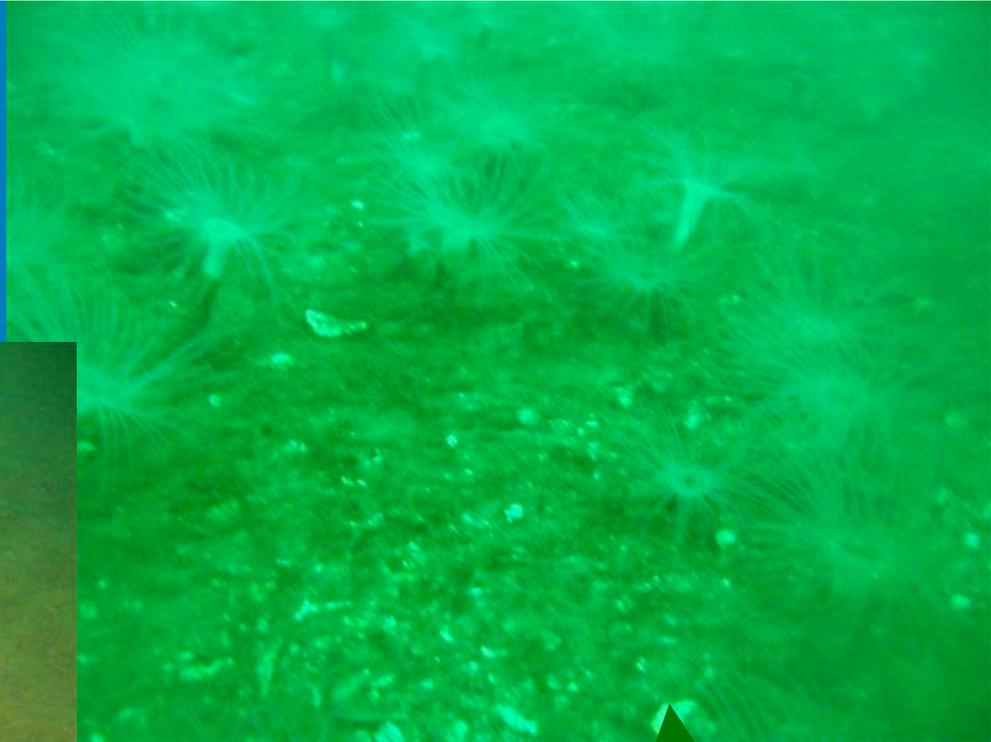
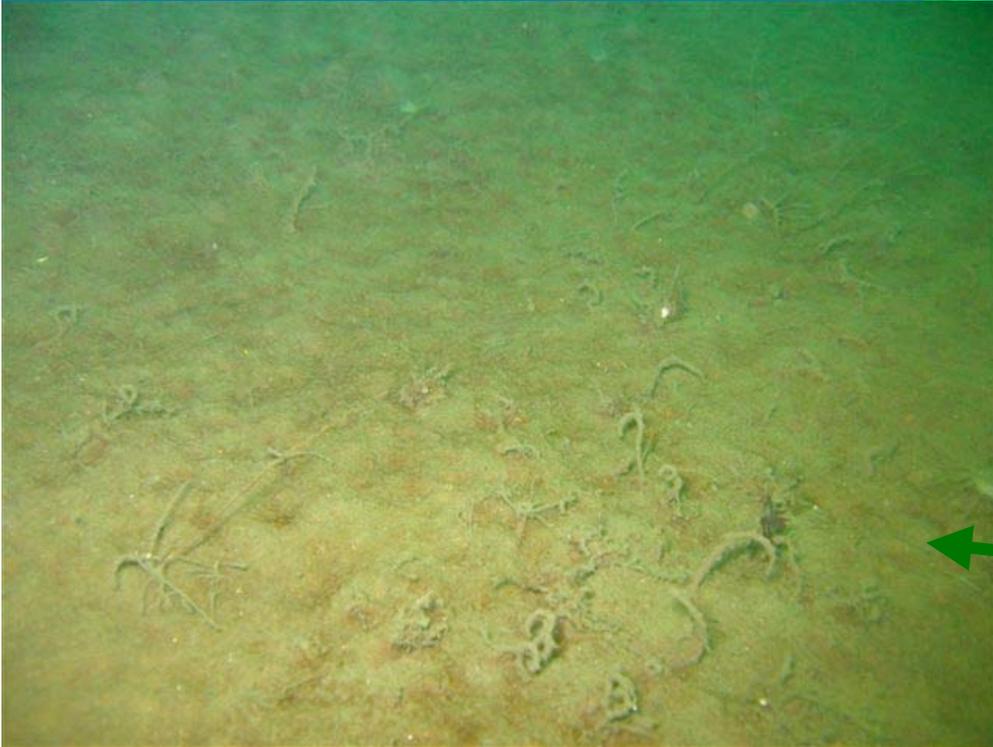
Photographs just within and 30 m outside the perimeter of accumulated waste.

Top photograph shows marine life on a gravel, rocky bottom (top)
Bottom photograph shows no visible life.

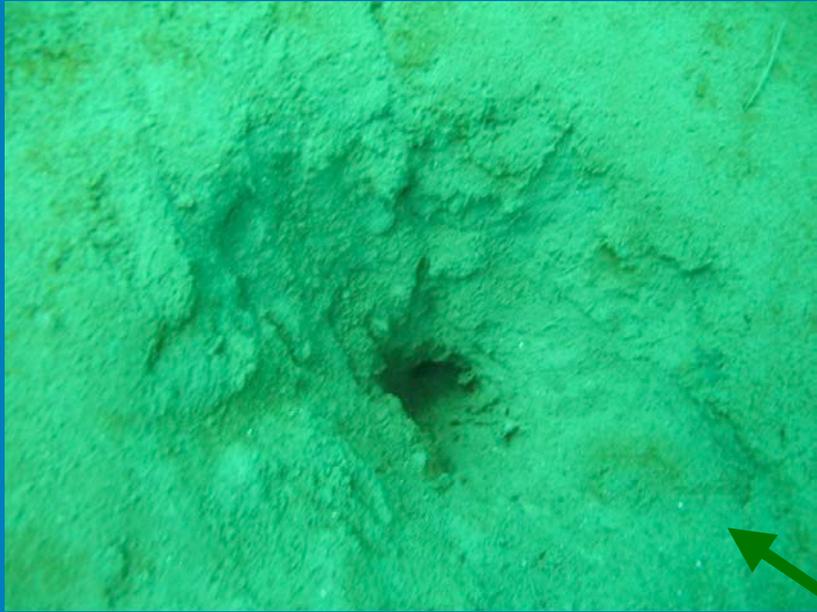
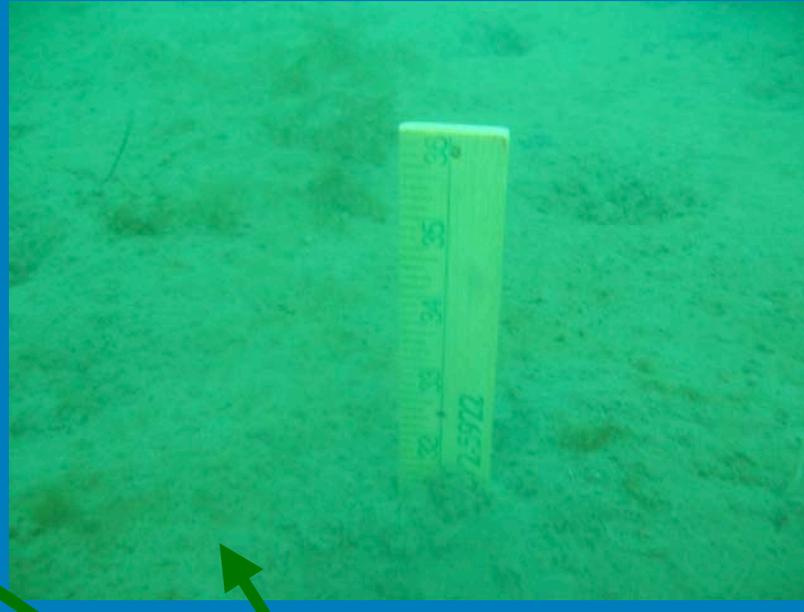
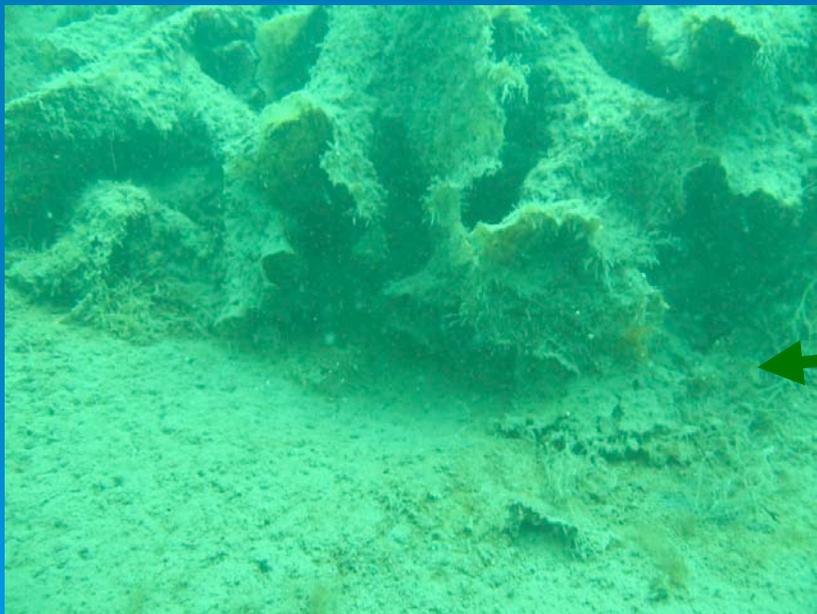
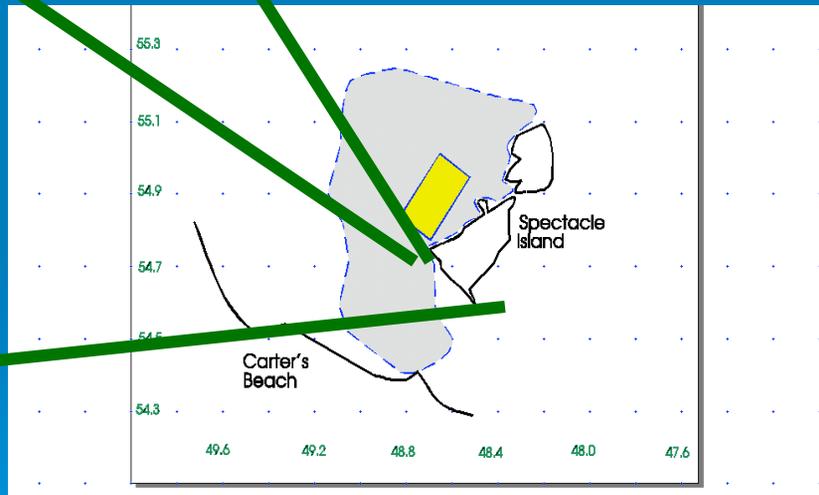
Photos near and distant from aquaculture site.

Bottom left shows coating of waste on marine life behind Spectacle Island.

Top left shows a gas vent revealing incremental deposits of waste
Top right shows a measure stick which did not reach the bottom of the waste deposit.

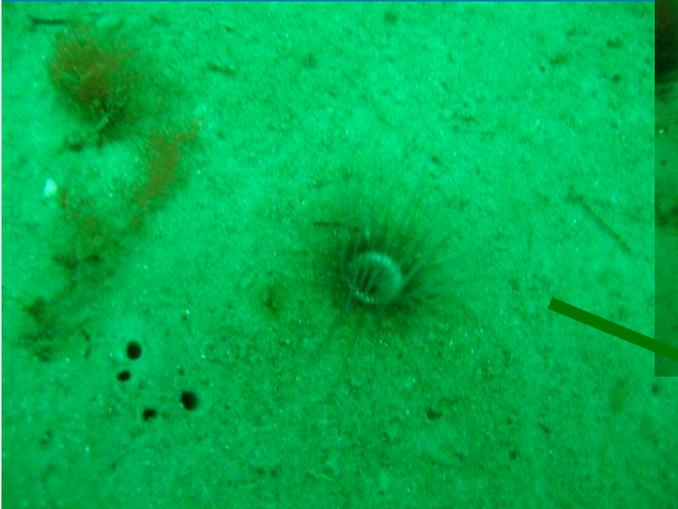
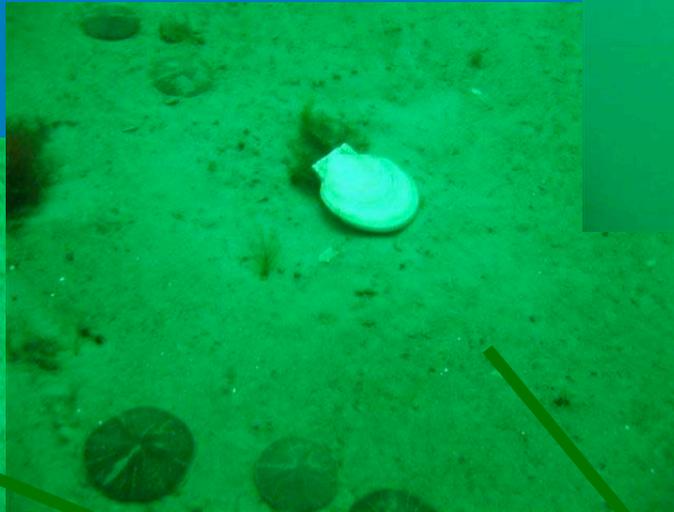
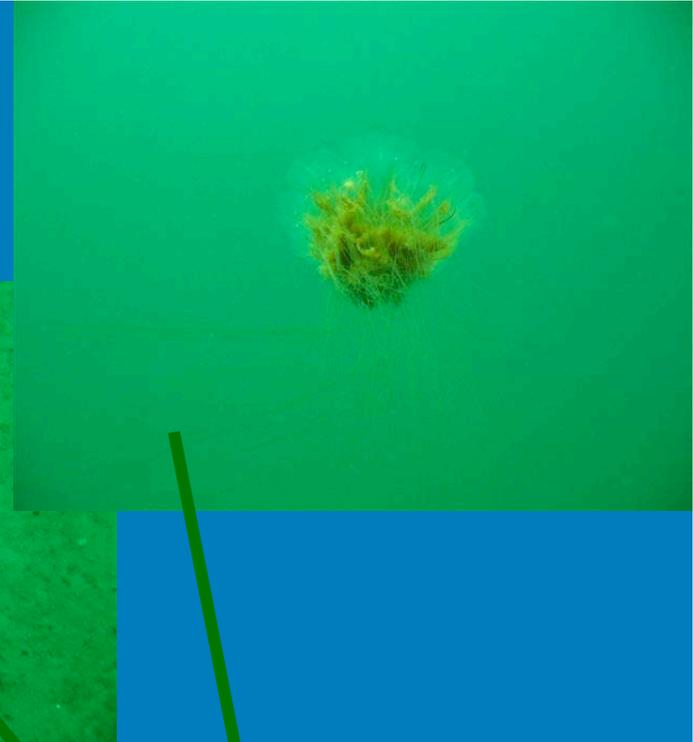
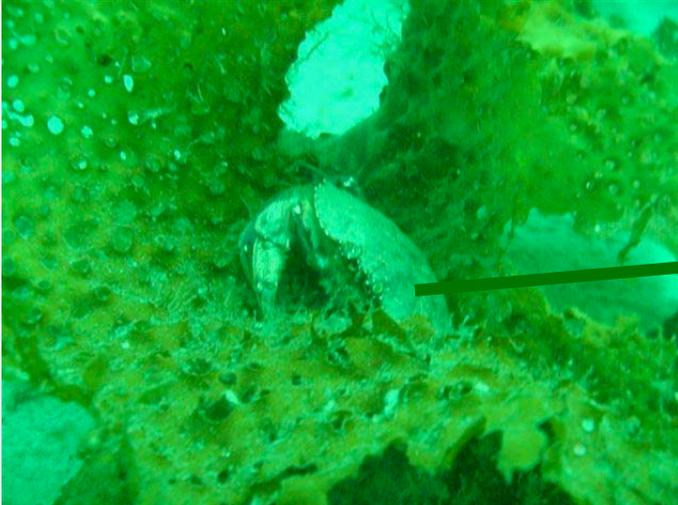
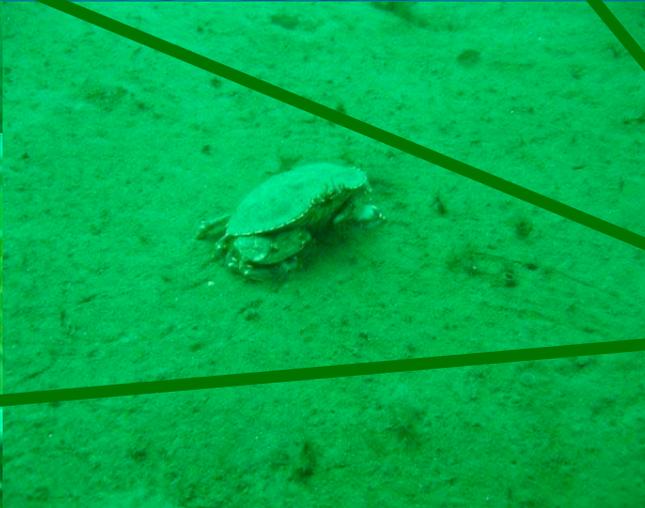
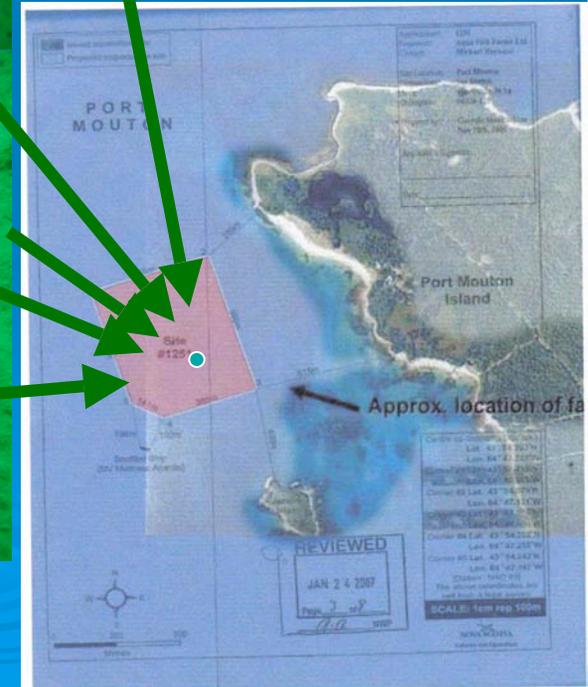
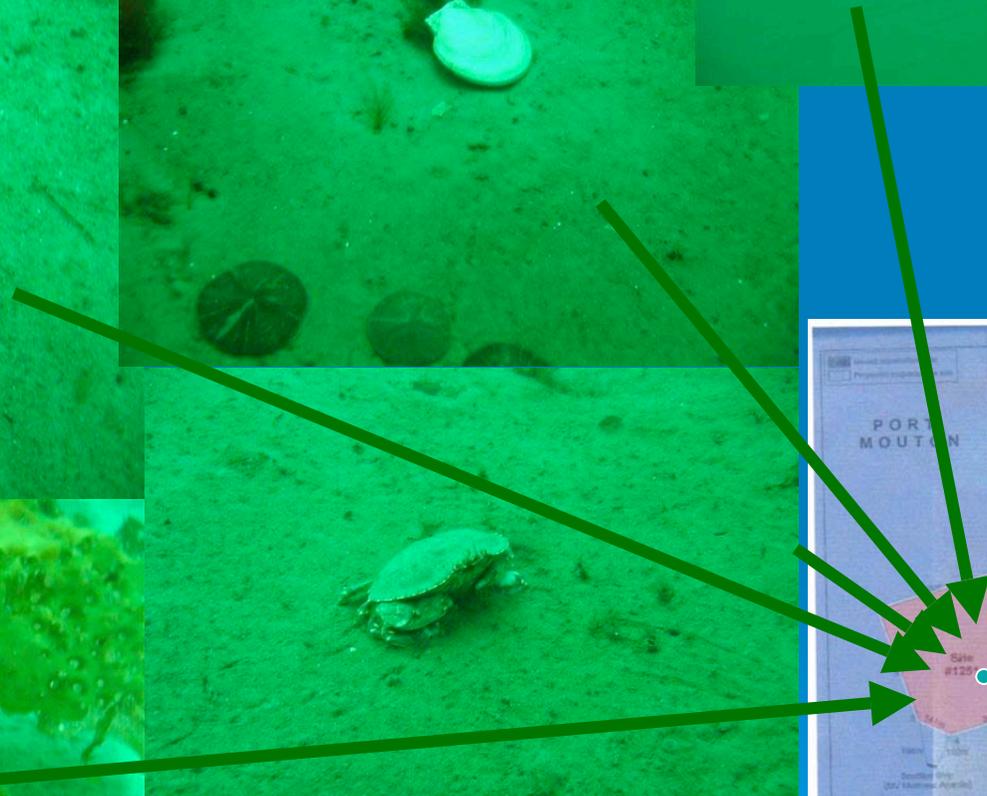
Divers' record of marine life at proposed aquaculture site,
Port Mouton Island, on August 1, 2007
